## Inspection Report

**Property Address:**  
123 Smith Ave NW  
Calgary Alberta BBB 123

**Bocc Home Inspections Ltd.**

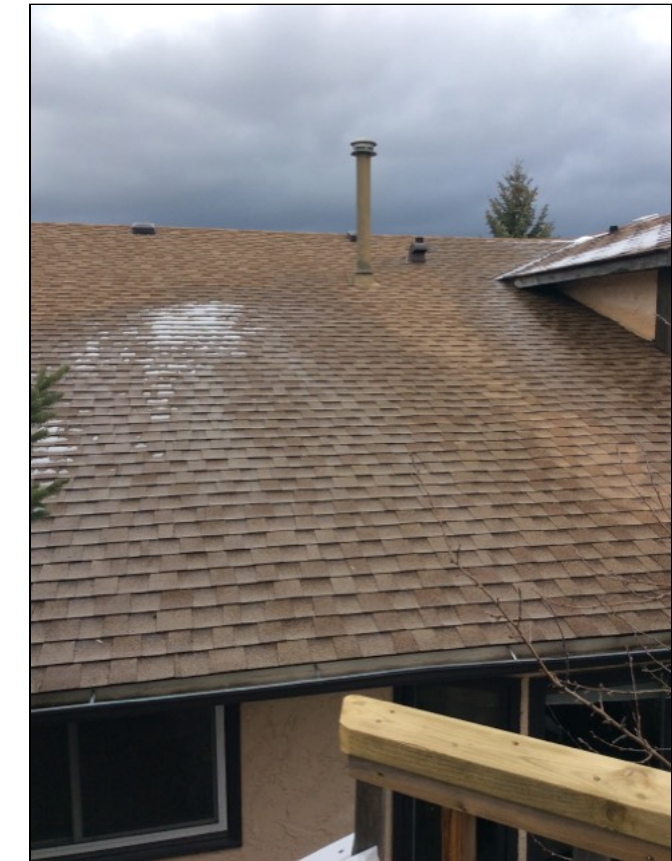
1.0 Item 1(Picture) South facing side of roof

Roof was limited to a visual inspection with the use of binoculars and from the second floor windows.

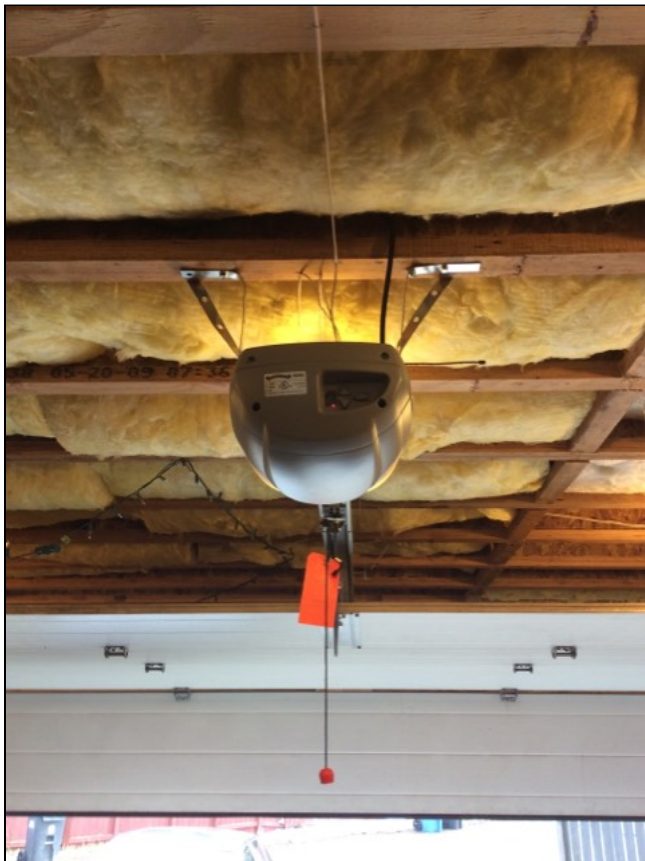
4.6 Item 1(Picture) Garage door motor

The photo eye laser reverse function worked properly at the time of the inspection, however the resistance reverse function did not. Recommend adjusting the sensitivity so that the door reverses with very little resistance, this is help to prevent form potential damage to the garage door as well potential injury.

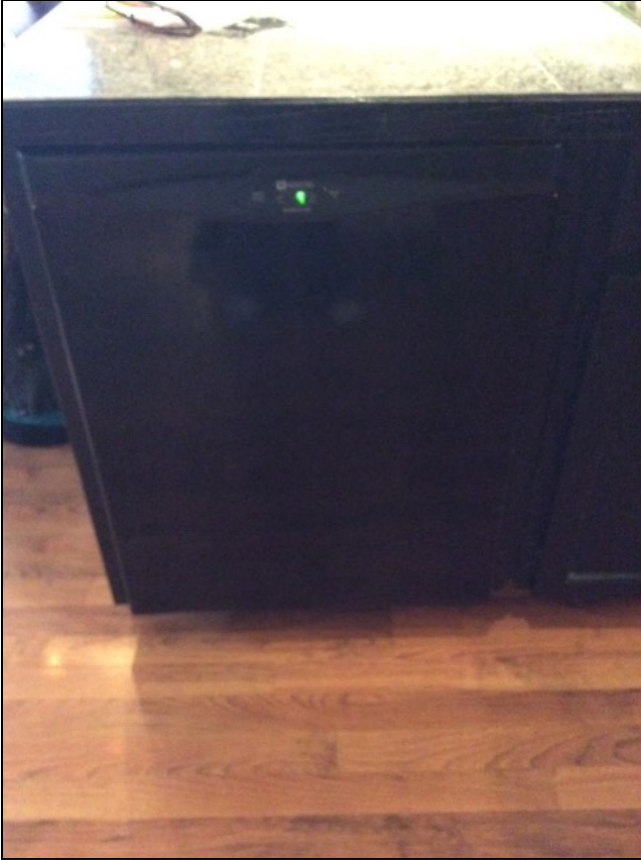
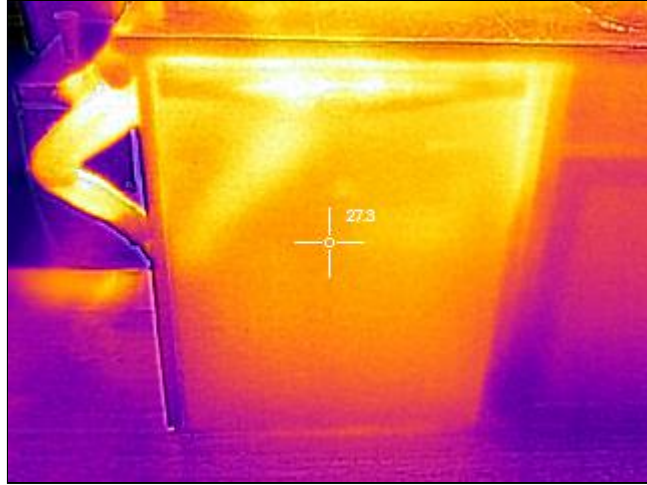
6.2 Item 1(Picture) Dishwasher

Dishwasher was tested by running on a regular cycle, it was working well on the day of the inspection, no leaks.

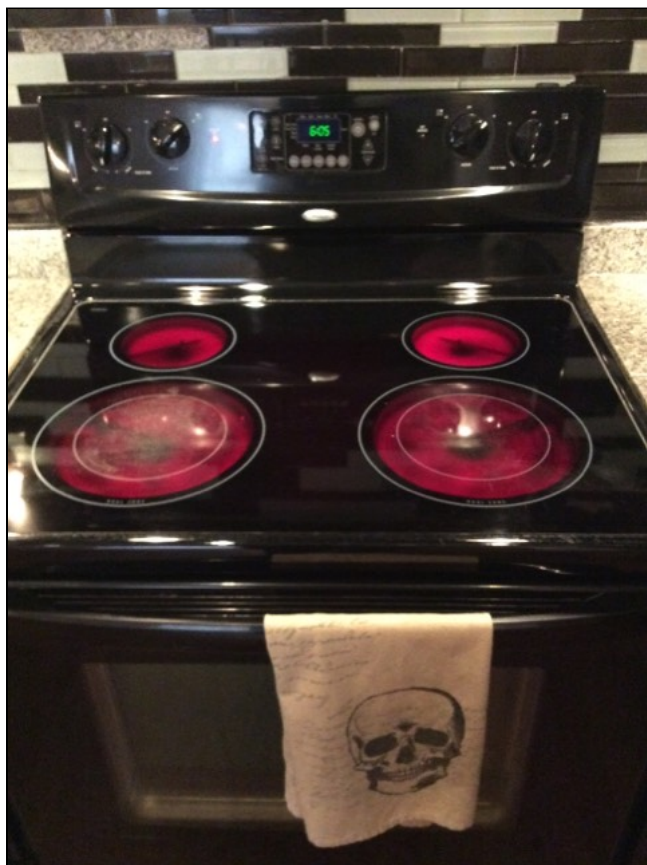
6.3 Item 1(Picture) Stove/cooktop

The electrical stove/range elements were tested at the time of inspection and appeared to function properly. The electric oven elements were tested at the time of inspection and appeared to function properly.

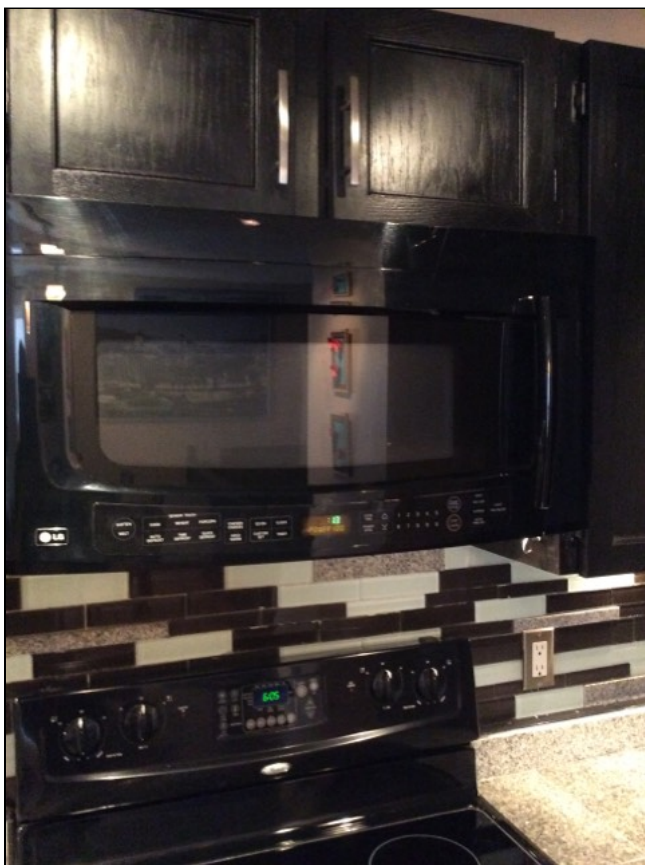
6.7 Item 1(Picture) Microwave

Built-in microwave ovens are tested using normal operating controls. Unit was tested and appeared to be serviceable at time of inspection.

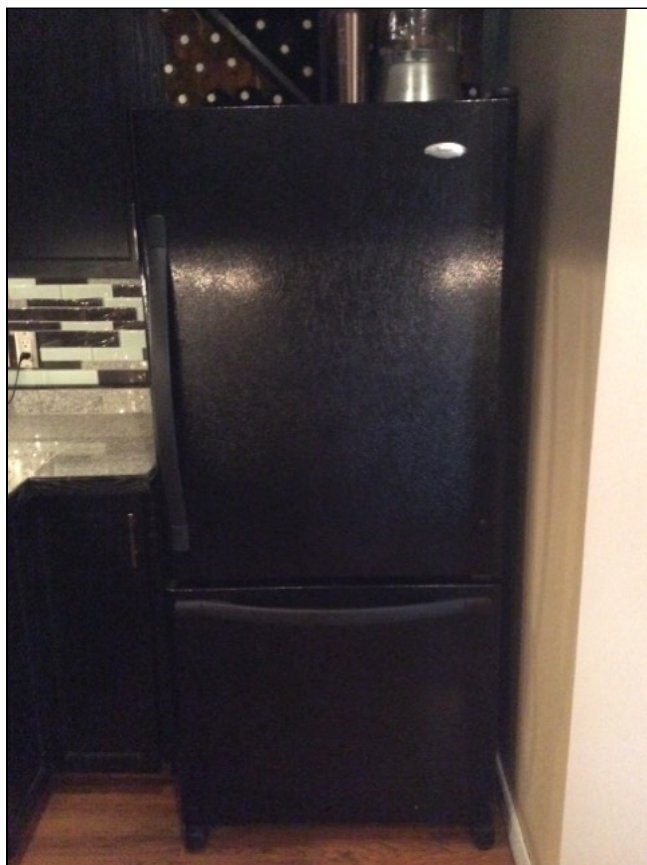
6.8 Item 1(Picture) Refrigerator

Our inspection of this item is purely to see if the internal walls are cold. Please note we do not use any special equipment to test these items. Also we DO NOT test water hook ups, water dispensers or icemakers connected to the refrigerators.

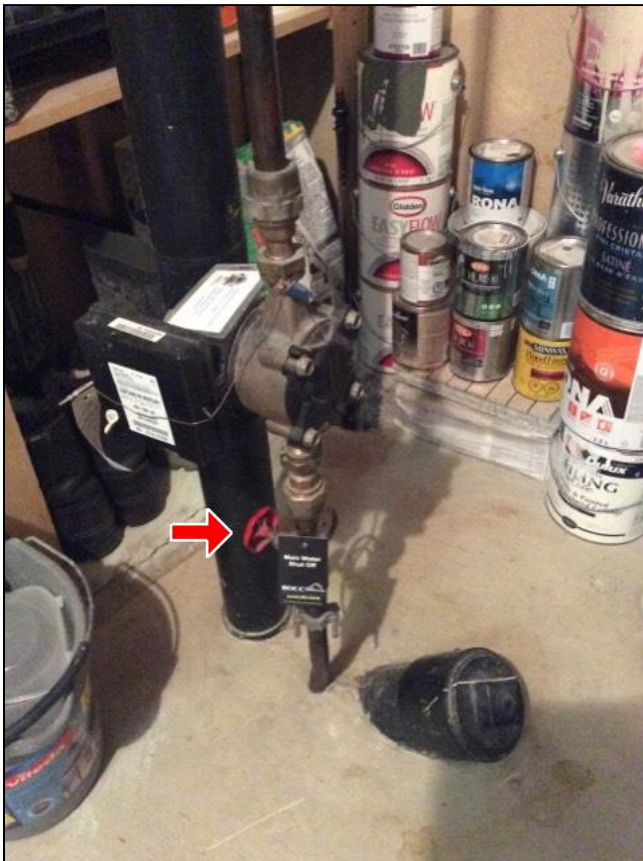
8.3 Item 1(Picture) Main water shut off

The main water shut off is marked with a tag and is located in the basement where the utilities are. No leaks at the time of inspection, ongoing monitoring of all plumbing is suggested.

Since main shut off valves are operated infrequently, it is not unusual for them to become inoperable over time. They often leak or break when operated after a period of inactivity. We suggest caution when operating shutoffs that have not been turned for a long period of time. All shutoff valves and angle stops should be turned regularly to ensure free movement in case of emergency.

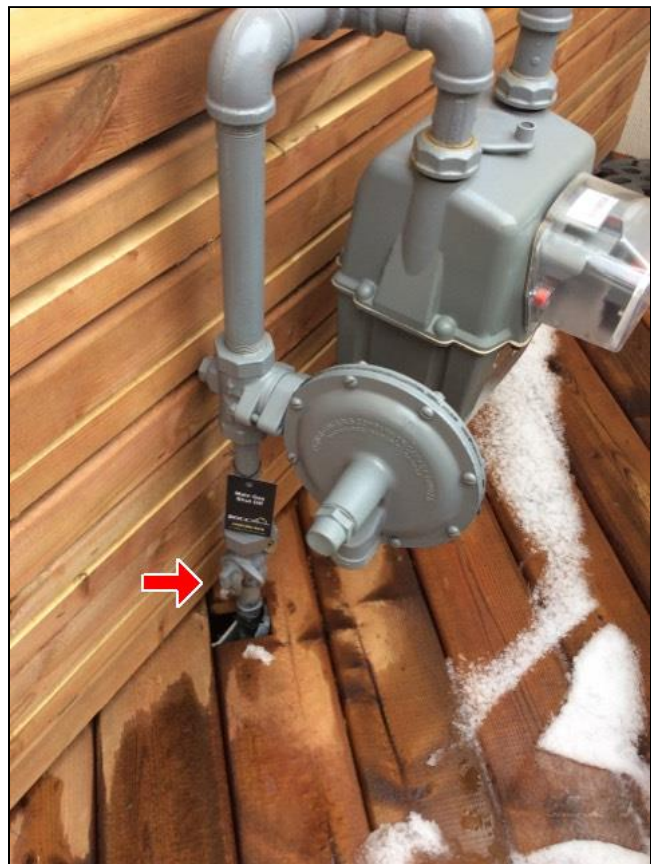
8.5 Item 1(Picture) Main gas shut off

The main gas shut off is located beside the gas meter on the side of the house.

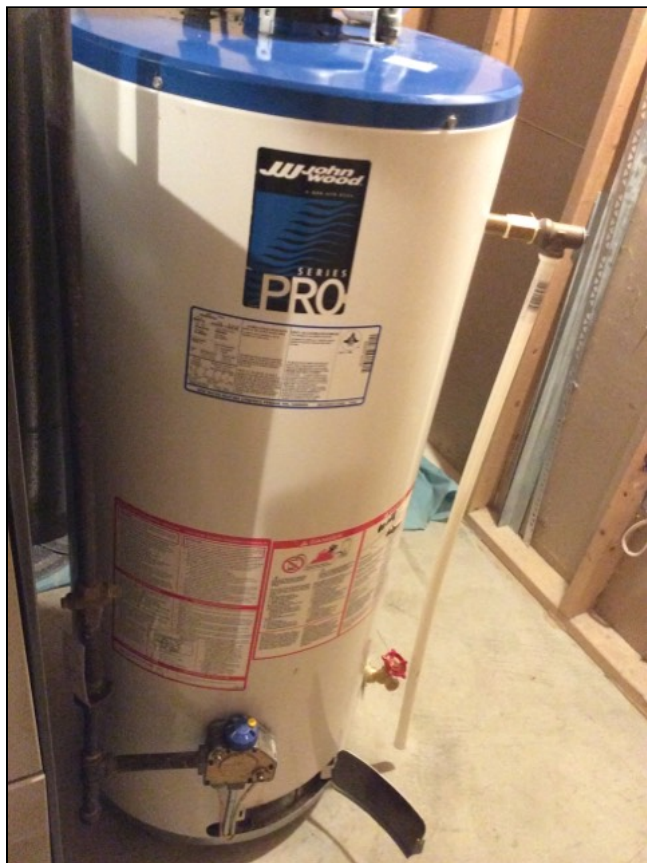
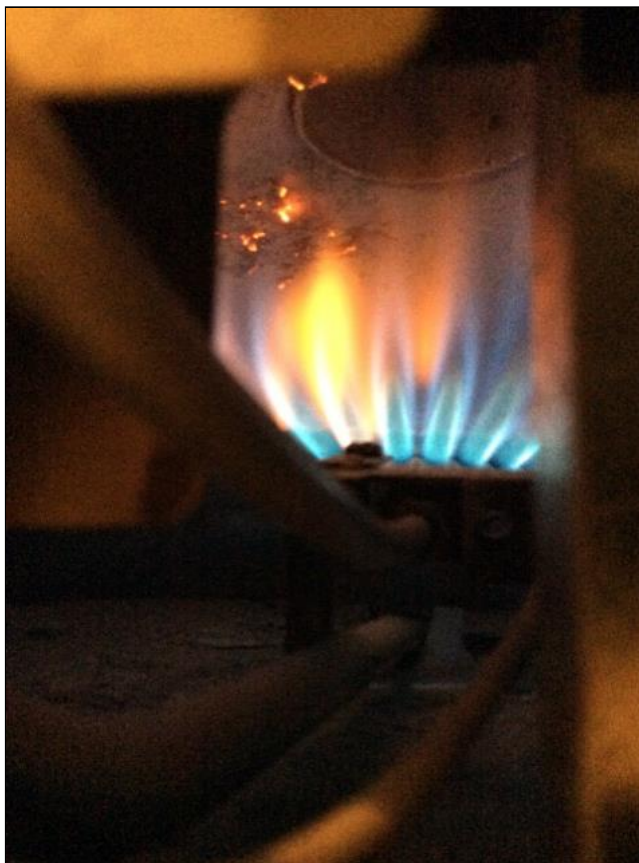
8.6 Item 1(Picture) Hot water tank

Hot water tank was serviceable at time of inspection. No warranties can be offered on this or any other appliance. Average life expectancy is about 10-12 years, though it can fail at anytime.

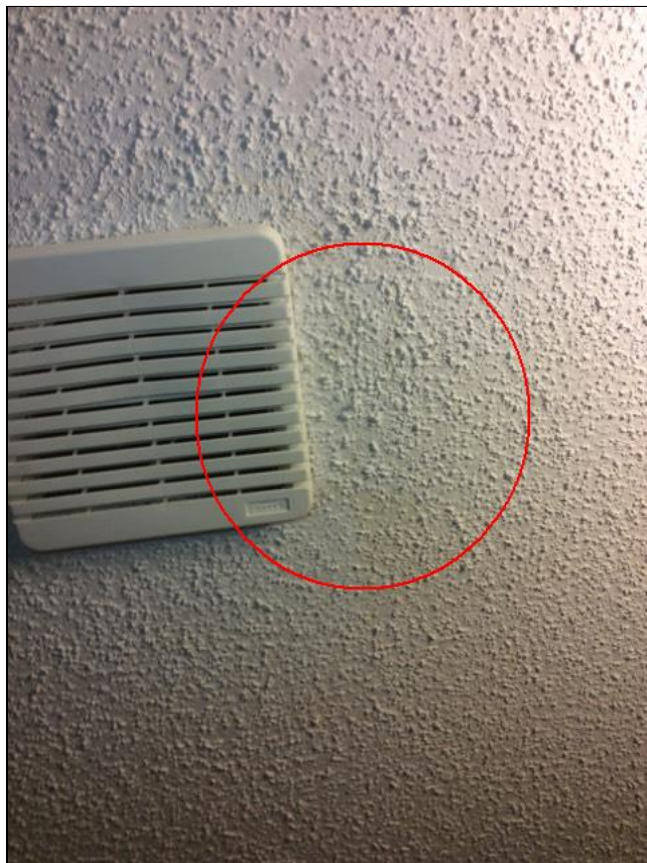
9.0 Item 1(Picture) Moisture stain in second main floor bathroom

All bathroom walls and ceiling were in good condition and dry at time of inspection, there was a moisture stain by the fan in the second main floor bathroom. This is mostly due to not running the fan long enough prior to showering/bathing, fans should be run for 20-30 mins after. (Cosmetic issues are not part of the inspection.)

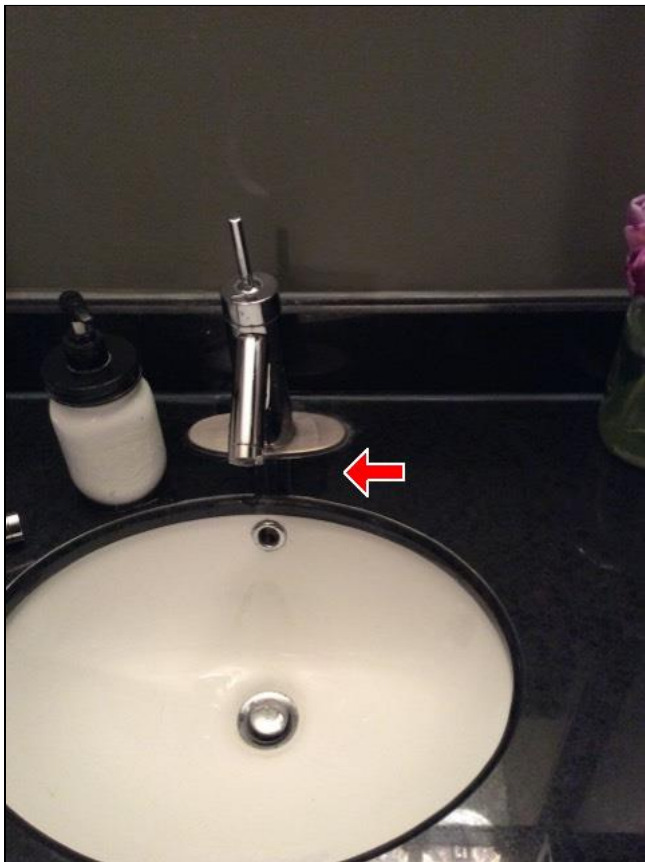
9.6 Item 1(Picture) Master en suite sink

Visible supply lines appeared in good condition and no leaks were found, except for in the master en suite. The water supply fixture was leaking and should be replaced to ensure that no water damage occurs to the cabinetry.

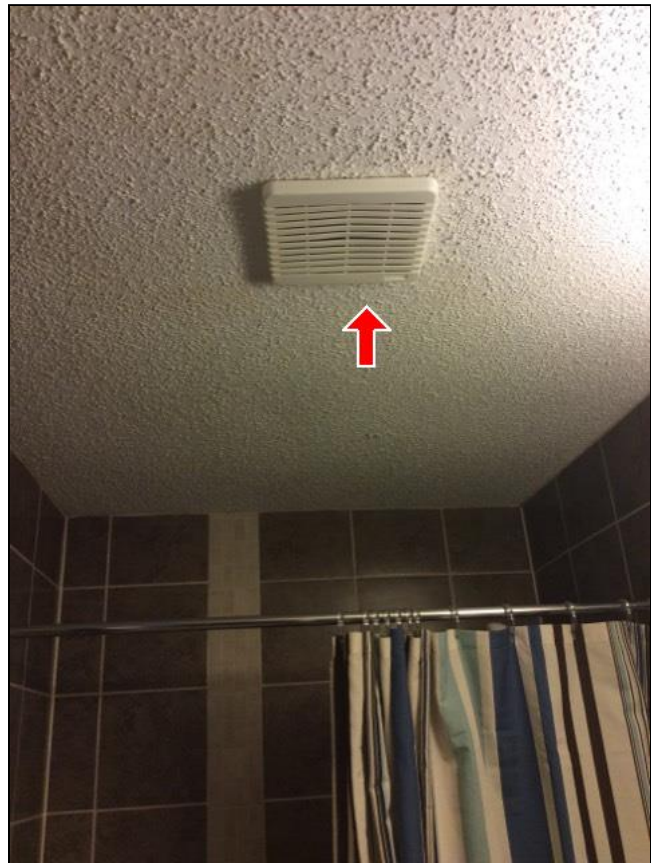
9.8 Item 1(Picture) Second main floor bathroom fan

The master en suite bathroom exhaust fan was operating in a serviceable condition, however the other main floor bathroom fan was not. I recommend a contractor further evaluate to find the issue and fix as necessary. It is recommended that your fans are run 20-30 minutes after a bath or shower to help reduce extra humidity from bathrooms.

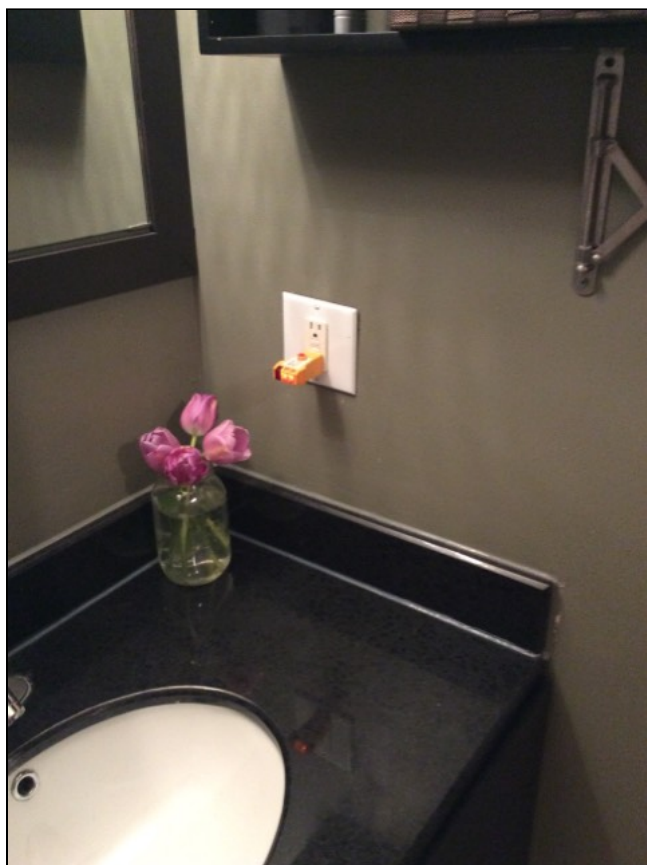
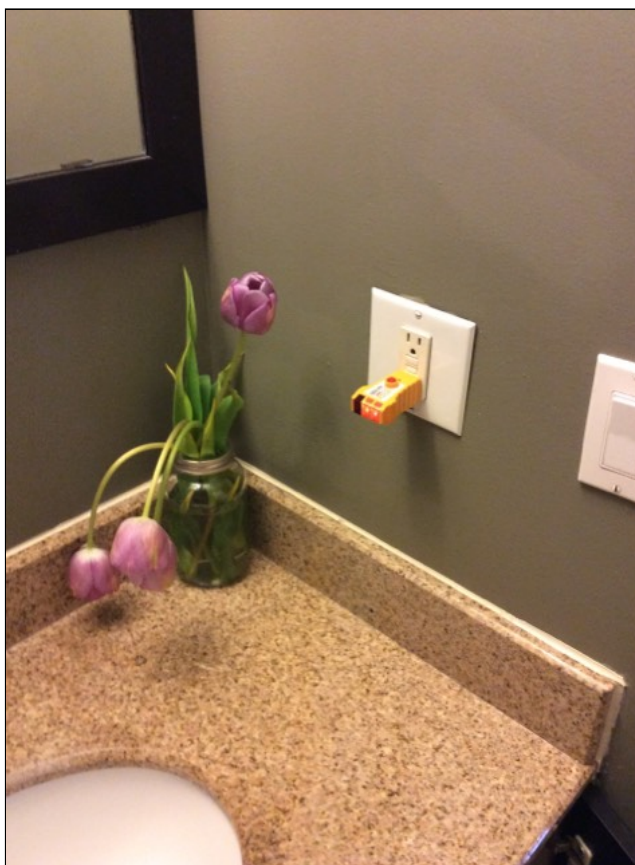
9.11 Item 1(Picture) GFCI

GFCI in place near water sources, these are tested using an outlet and GFCI tester. Neither GFCI in both upper floor bathrooms were operational, I recommend that a journeyman electrician replace the GFCI's with new ones to ensure the safety of the owners.

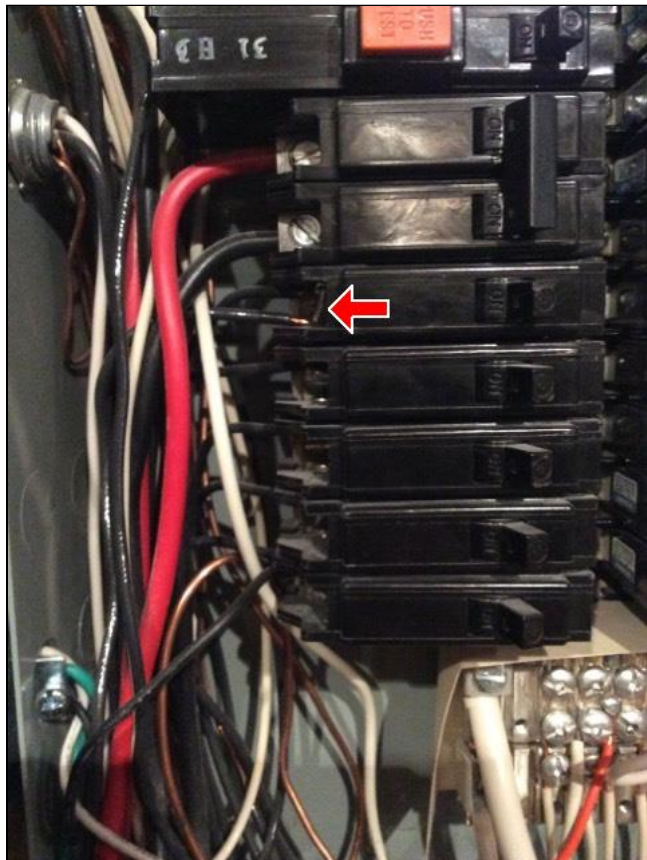
10.3 Item 1(Picture) Double tapped wire

In the main distribution panel there was a "double tapped" breaker and another breaker in which the wire appeared to be really loose. I recommend that a journeyman electrician further investigate and fix as necessary to avoid potential hazards.

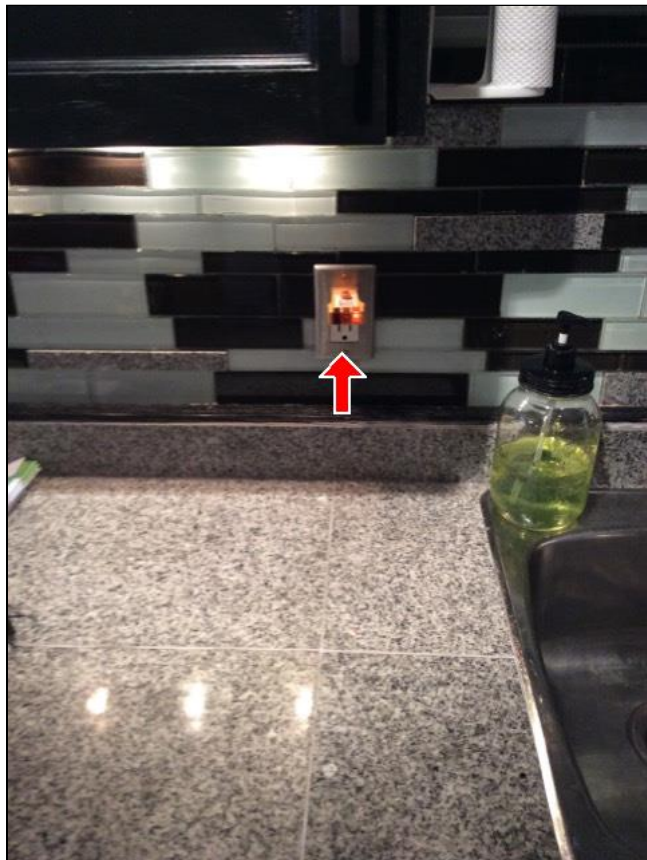
10.5 Item 1(Picture) Open neutral plug in kitchen

The receptacle in the kitchen beside the sink shows "open neutral" this means that the neutral wire is either loose or not connected. I recommend that a journeyman electrician further address and fix as necessary.

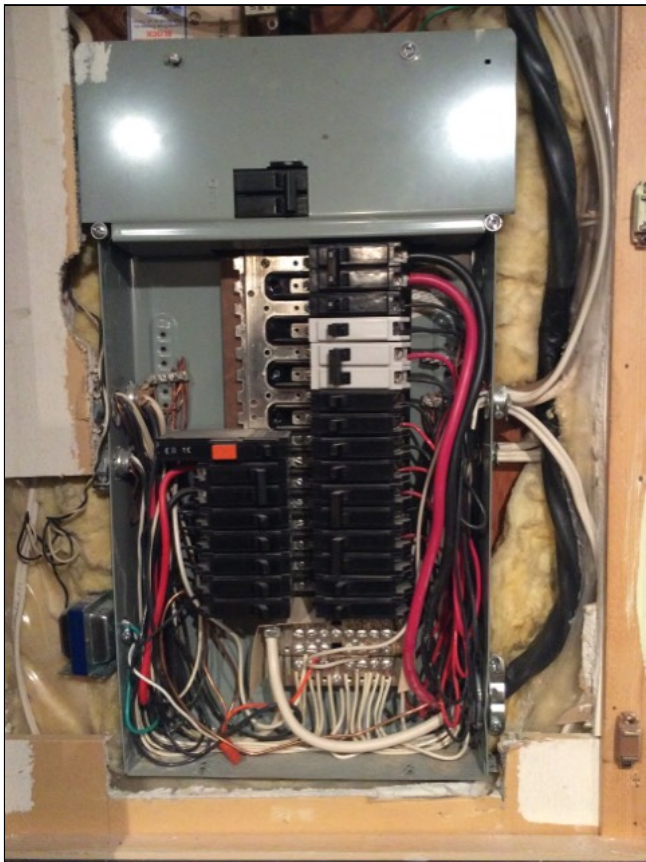
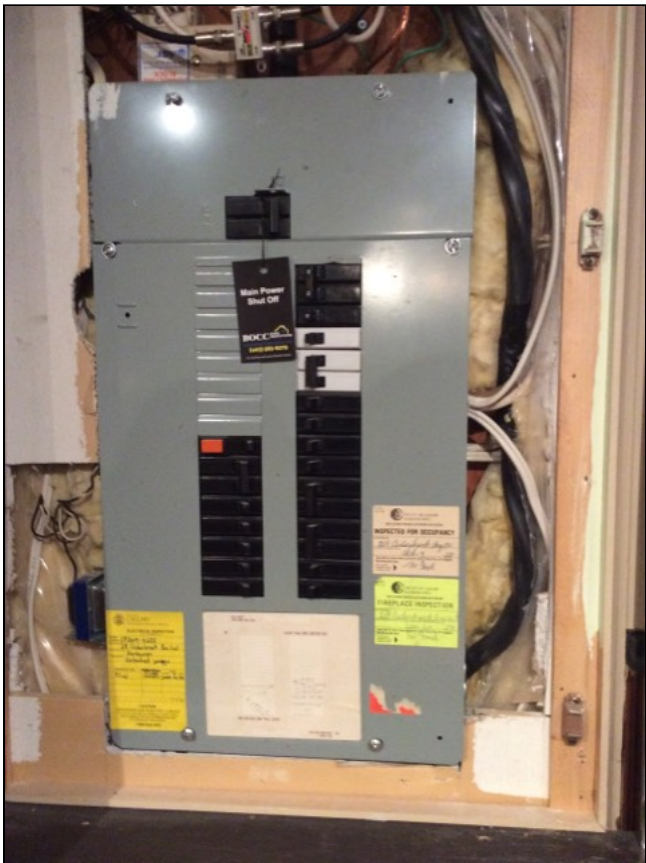
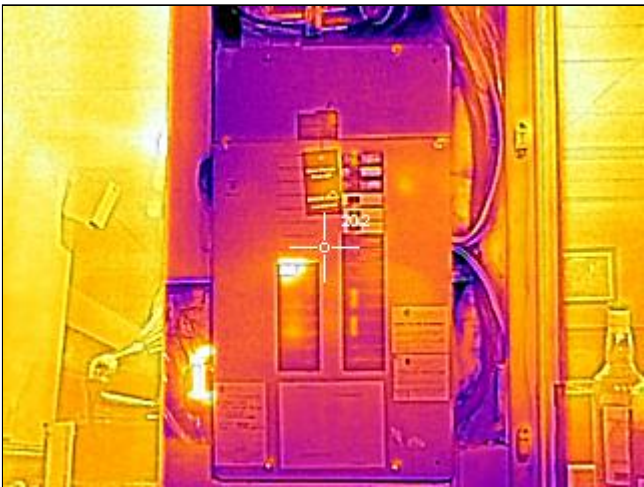
10.7 Item 2(Picture) Main distribution panel

The main distribution panel is located in the basement rec room behind the bar.

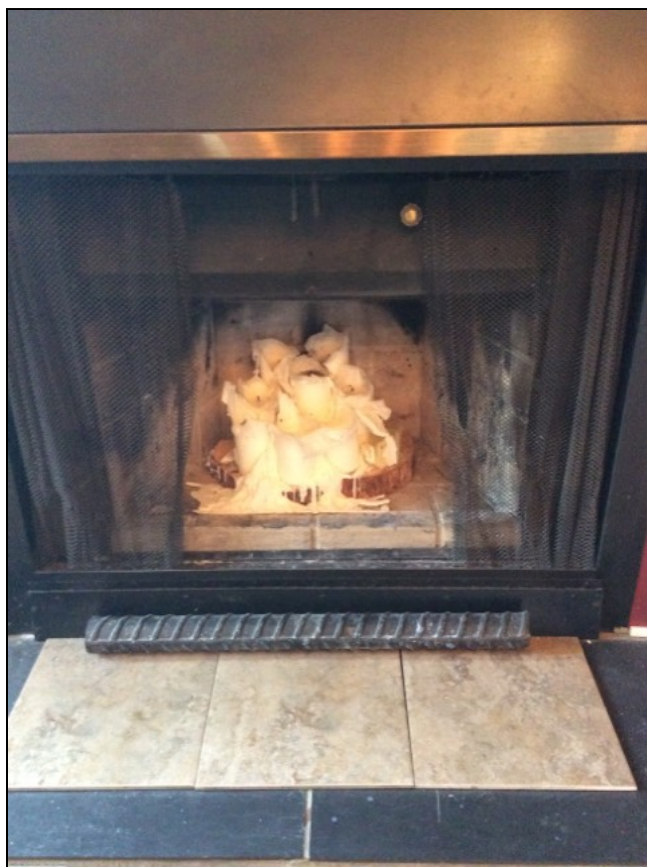
11.8 Item 1(Picture) Fireplace

Our flue inspection is minimal of the visual component only, for full chimney review suggest W.E.T.T inspection prior to use.

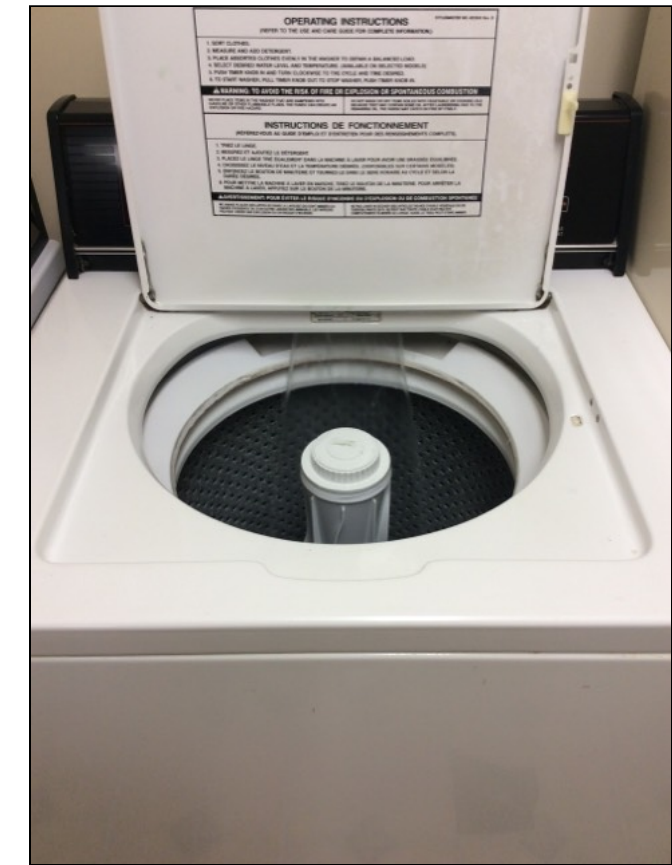
12.0 Item 1(Picture) Washing machine

The washing machine was run on a short cycle to test its operation and inspect for leaks. It worked as required on the day of the inspection. This test does not assess it's performance or ability to wash clothes effectively.
